# LAKE OCQUITTUNK NJ 00260

## PHASE 1 INSPECTION REPORT NATIONAL DAM SAFETY PROGRAM

REPT. NO: DAEN/NAP-53842/NJ-00260-81/07<sup>D</sup>

JULY 1981

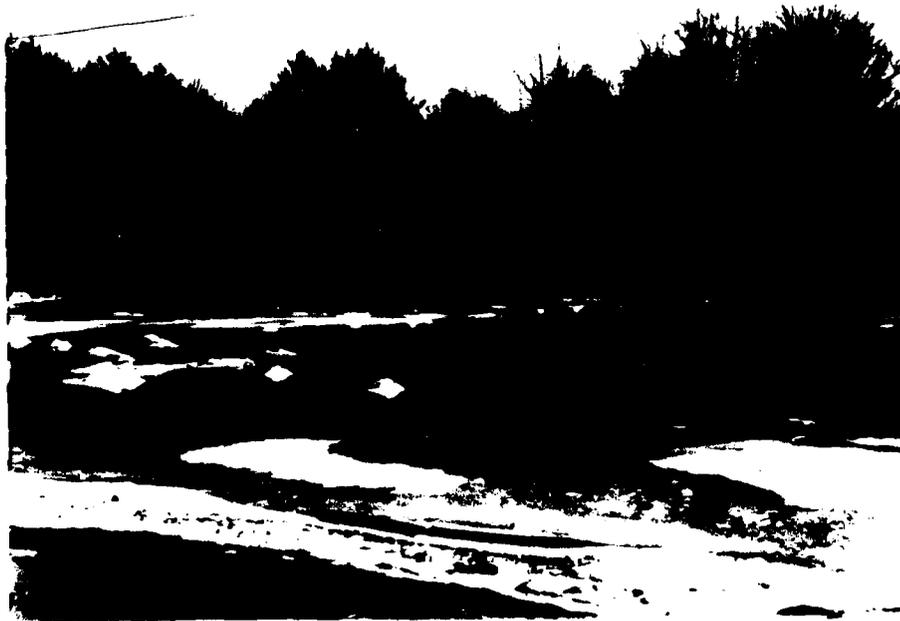
Influent Canal & Sedimentation Pond

VISUAL EXAMINATION OF	OBSERVATIONS	REMARKS OR RECOMMENDATIONS
SLOPES	Moderate to steep. Underdeveloped and heavily wooded. Lake and pond completely frozen. Combination of ice and sedimentation may be preventing flow between lake and sedimentation pond.	Culverts should be checked when ice thaws. Culverts should be cleared if blocked. Unable to observe conditions of culverts at present.
SEDIMENTATION	None observed but park personnel advise pond is almost completely filled with silt. This may be responsible for constriction at connecting culverts. More likely due to ice.	Sedimentation pond should be dredged back to original grades.

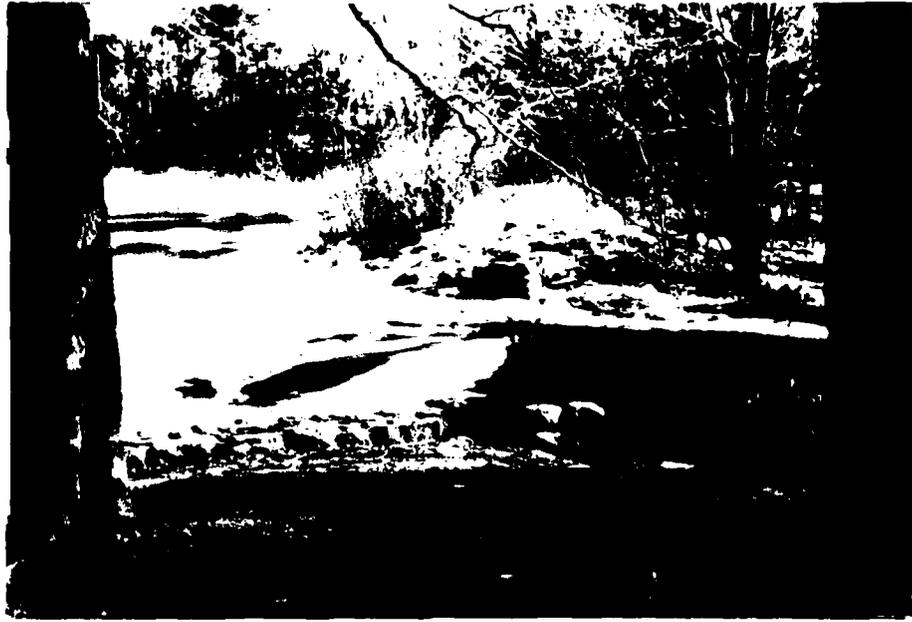
Dike Crest and Auxiliary Spillway

VISUAL EXAMINATION OF	OBSERVATIONS	REMARKS OR RECOMMENDATIONS
CONCRETE WEIR	Auxiliary spillway on sedimentation pond in good condition. Sidewalls need repointing. Some stone missing.	Masonry should be replaced and repointed.
APPROACH CHANNEL	None	
DISCHARGE CHANNEL	Paved masonry apron and riprap channel clear and at true grade.	Several inches of flow discharging smoothly over weir and apron.
BRIDGE AND PIERS	None.

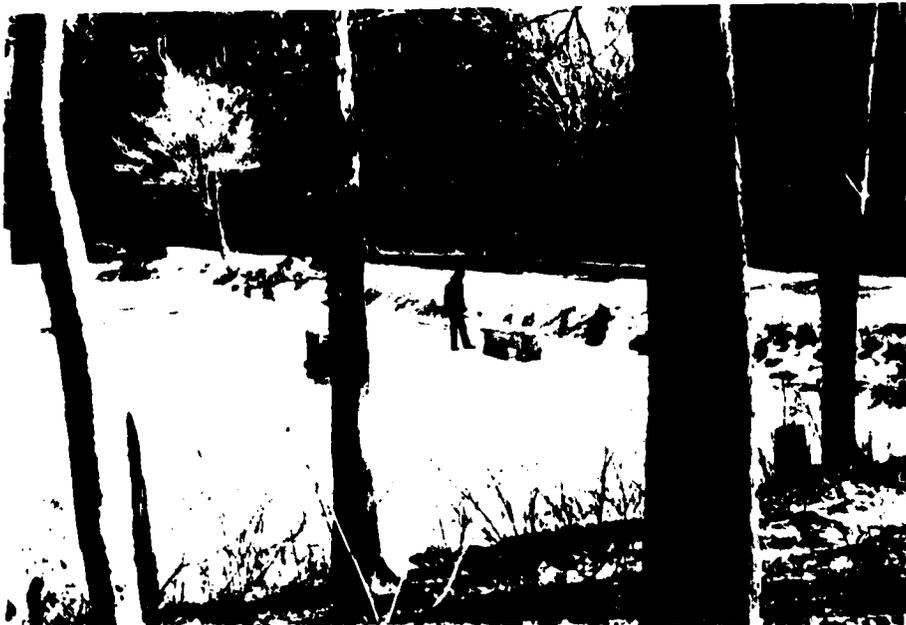
Dam Crest and Gate Control Structure

The only regulating component at this dam is the 24-inch-diameter C.I. drain. As indicated above, park maintenance personnel are responsible for its maintenance. At the time of the inspection, the wheel was missing from the gate stem; presumably, the park personnel remove the wheel when it is not in use to prevent vandalism.

(4) Inspect, repair, and test the valve for the drain.
